WAD 2917 #75 11/4/1999

PORT OF SEATTLE/
BURLINGTON ENVIRONMENTAL, INC.
TERMINAL 91 FACILITY
SEATTLE, WASHINGTON

FINAL RESOURCE CONSERVATION AND RECOVERY ACT FACILITY ASSESSMENT

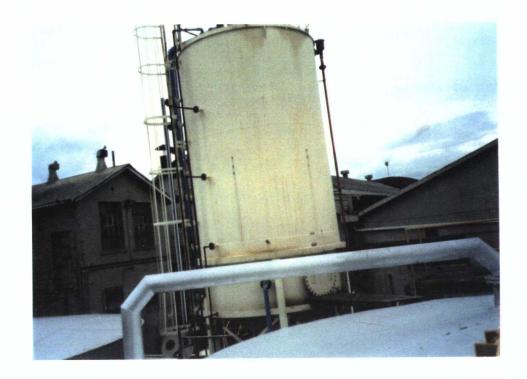
Photograph: 1 Date: October 20, 1992 Taken By: Noushin Arab

Description: Chempro/Burlington Tank 164 (SWMU 18)

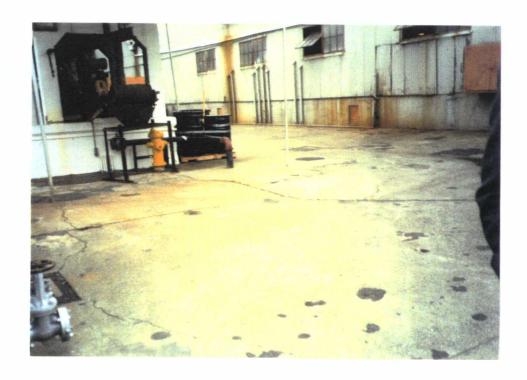
Photograph: 2 Date: October 20, 1992 Taken By: Noushin Arab

Description: Sewer line at Burlington (SWMU 19)

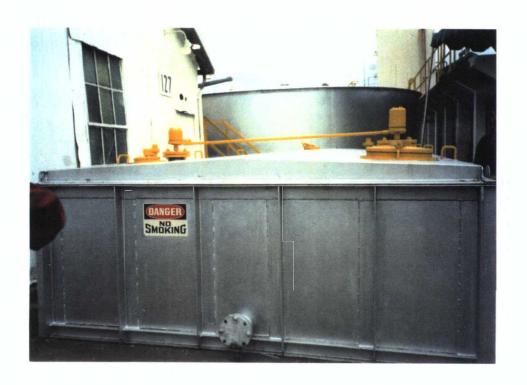
Photograph: 3 Date: October 20, 1992 Taken By: Noushin Arab

Description: Burlington API Gravity Separator (SWMU 20)

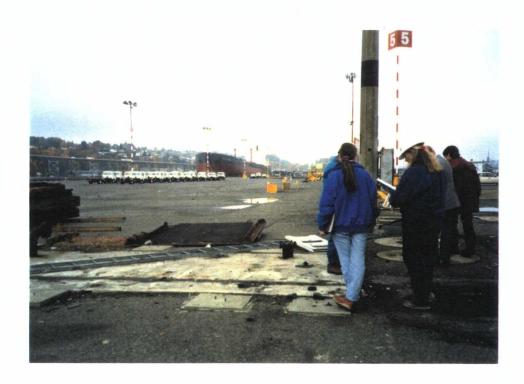
Photograph: 4 Date: October 21, 1992 Taken By: Noushin Arab

Description: Abandoned oil/water separator end of Pier 91 (SWMU 41)

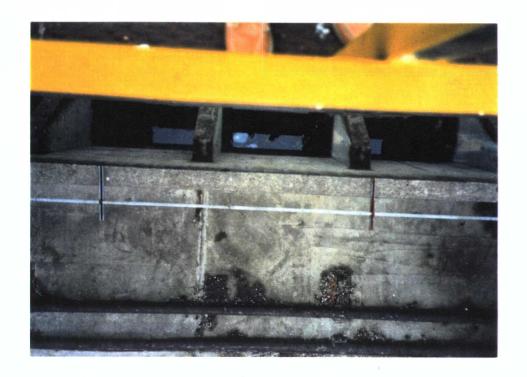
Photograph: 5 Date: October 20, 1992 Taken By: Noushin Arab

Description: Concrete berms at PANOCO (SWMU28)

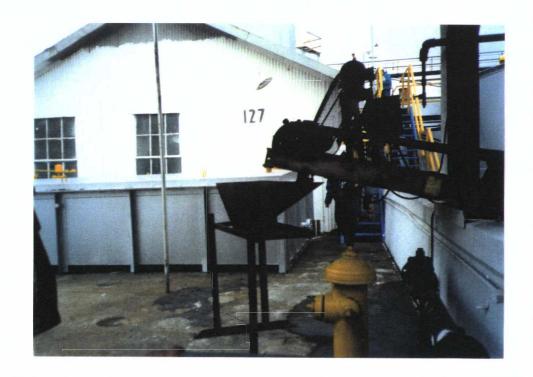
Photograph: 6 Date: October 20, 1992 Taken By: Noushin Arab

Description: PANOCO building 127 (SWMU 29)

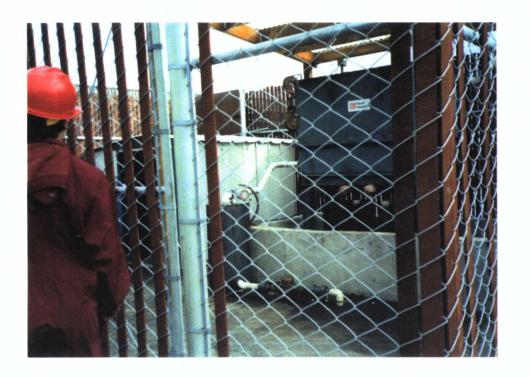
Photograph: 7 Date: October 20, 1992 Taken By: Noushin Arab

Description: PANOCO liquid hydrocarbon recovery system (SWMU 31)

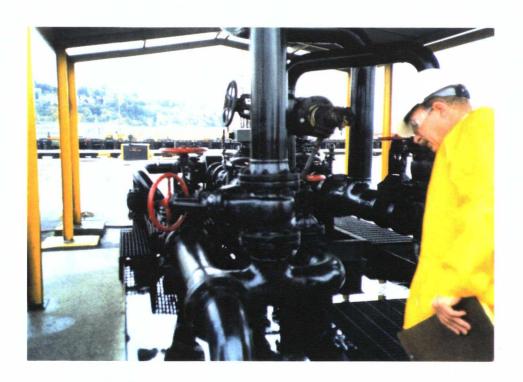
Photograph: 8 Date: October 20, 1992 Taken By: Noushin Arab

Description: PANOCO oil blending station (SWMU 32)

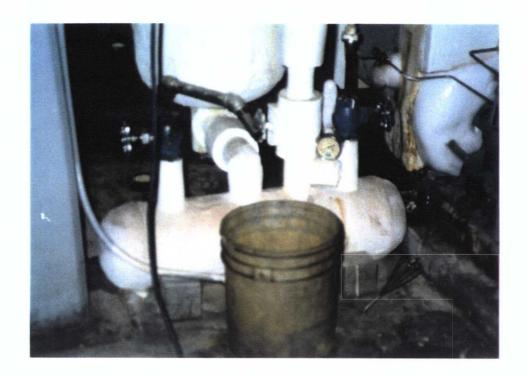
Photograph: 9 Date: October 21, 1992 Taken By: Noushin Arab

Description: Waste oil buckets used at City Ice and Cold Storage Co. (SWMU 34)

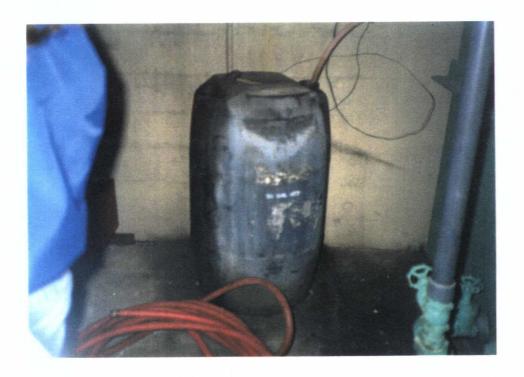
Photograph: 10 Date: October 21, 1992 Taken By: Noushin Arab

Description: Waste oil storage container at City Ice and Cold Storage Co. (SWMU 34)

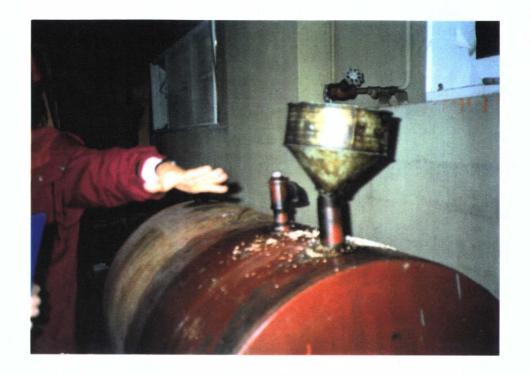
Photograph: 11 Date: October 21, 1992 Taken By: Noushin Arab

Description: Waste oil storage tank at City Ice and Cold Storage Co. (SWMU 34)

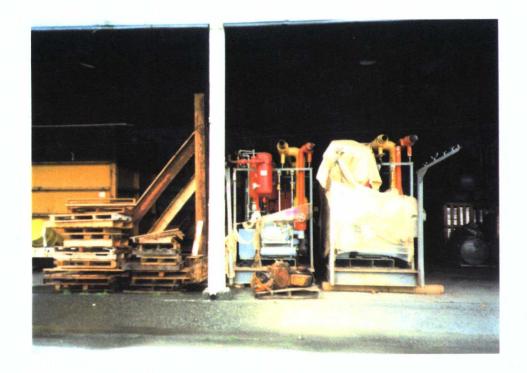
Photograph: 13 Date: October 21, 1992 Taken By: Noushin Arab

Description: Old refrigeration unit outside building W-47 (SWMU 35)

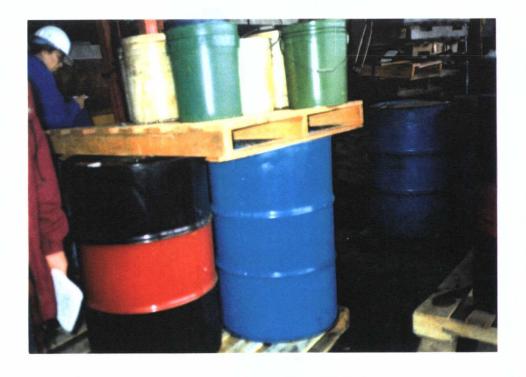
Photograph: 14 Date: October 21, 1992 Taken By: Noushin Arab

Description: 55-gallon drum of transformer oil outside building W-47 (SWMU 35)

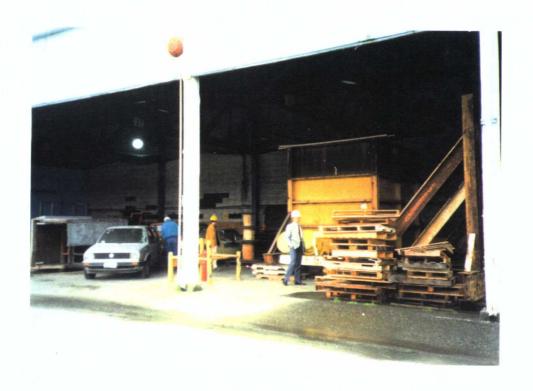
Photograph: 15 Date: October 21, 1992 Taken By: Noushin Arab

Description: 15 foot-tall bin with unknown contents (SWMU 35)

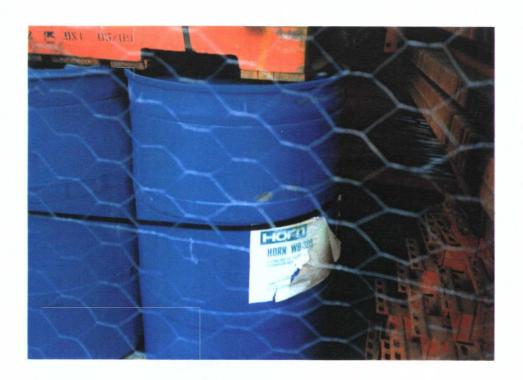
Photograph: 16 Date: October 21, 1992 Taken By: Noushin Arab

Description: 55-gallon drums labeled "concrete curing" (SWMU 35)

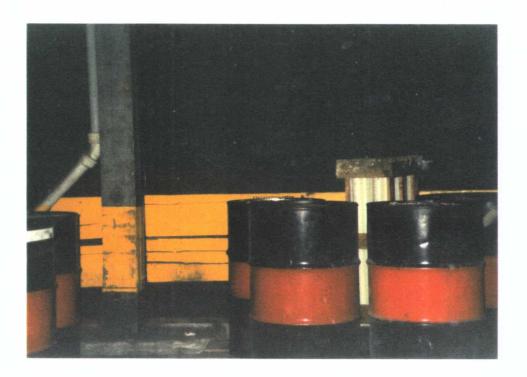
Photograph: 17 Date: October 21, 1992 Taken By: Noushin Arab

Description: 55-gallon drums of product motor oil inside building W-47 (SWMU 36)

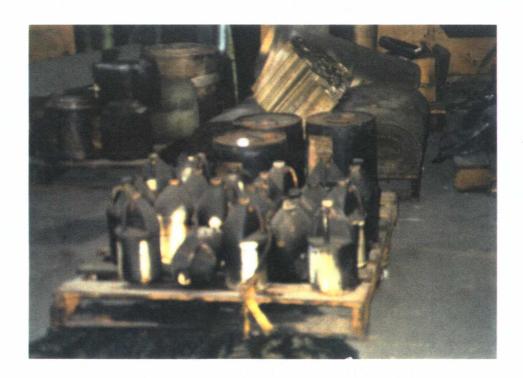
Photograph: 18 Date: October 21, 1992 Taken By: Noushin Arab

Description: Containers of mineral acids inside building W-47 (SWMU 36)

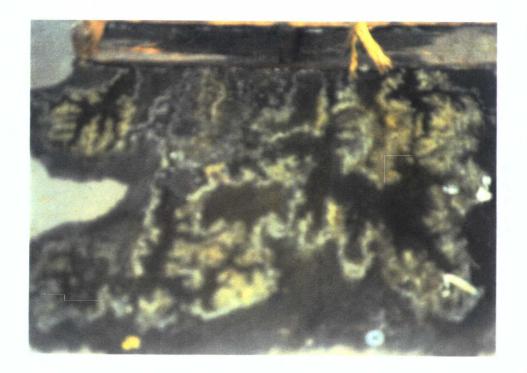
Photograph: 19 Date: October 21, 1992 Taken By: Noushin Arab

Description: Release of mineral acids on the concrete inside building W-47 (SWMU 36)

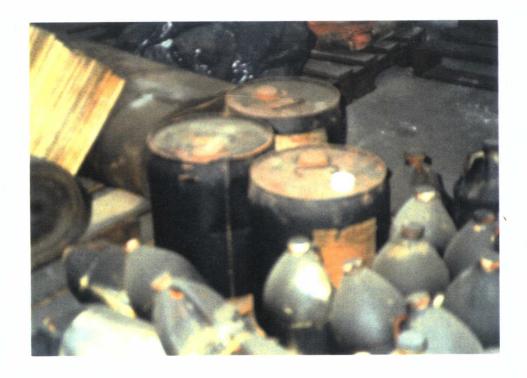
Photograph: 20 Date: October 21, 1992 Taken By: Noushin Arab

Description: Containers of mineral thinner inside building W-47 (SWMU 36)

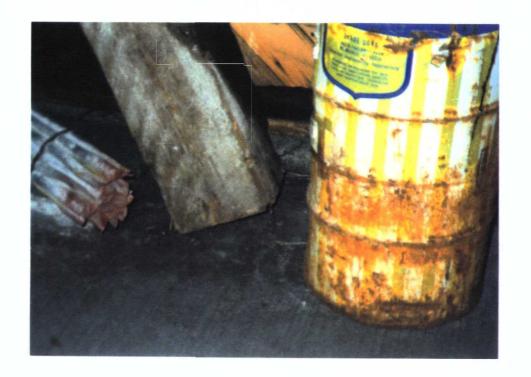
Photograph: 21 Date: October 21, 1992 Taken By: Noushin Arab

Description: 55-gallon drums of unknown content inside building W-47 (SWMU 36)

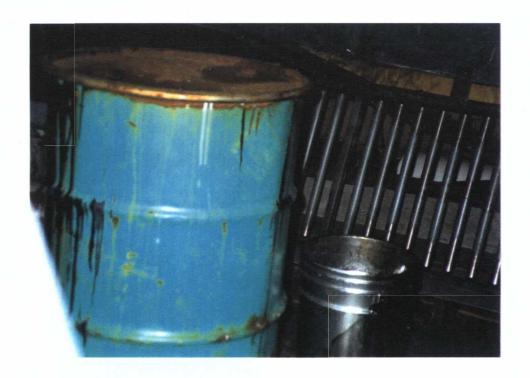
Photograph: 22 Date: October 21, 1992 Taken By: Noushin Arab

Description: 55-gallon drum with unknown content inside building W-47 (SWMU 36)

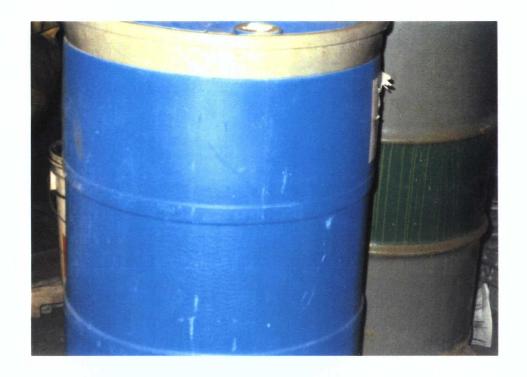
Photograph: 23 Date: October 21, 1992 Taken By: Noushin Arab

Description: 55-gallon drums of unknown content inside building W-47 (SWMU 36)

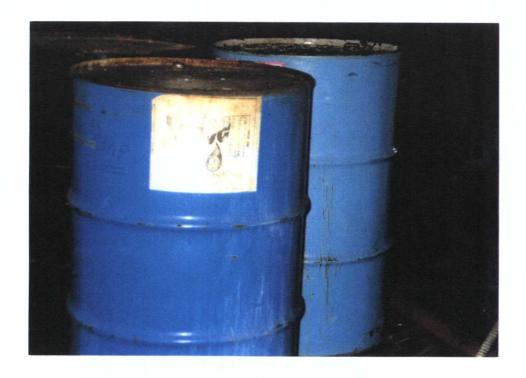
Photograph: 24 Date: October 21, 1992 Taken By: Noushin Arab

Description: 55-gallon drums of unknown content inside building W-47 (SWMU 36)

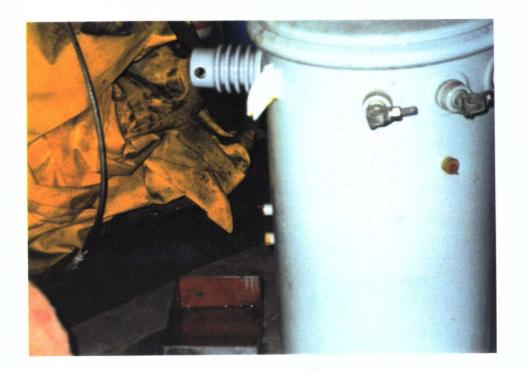
Photograph: 25 Date: October 21, 1992 Taken By: Noushin Arab

Description: Transformer and drip pan inside building W-47 (SWMU 36)

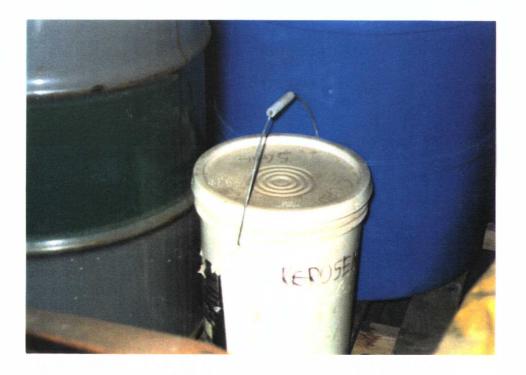
Photograph: 26 Date: October 21, 1992 Taken By: Noushin Arab

Description: Kerosene container inside building W-47 (SWMU 36)

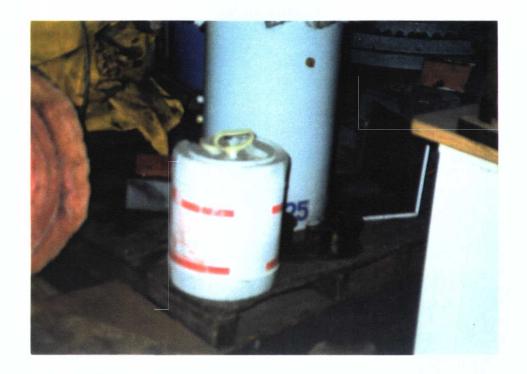
Photograph: 27 Date: October 21, 1992 Taken By: Noushin Arab

Description: Container of fiberglass compounds (SWMU 36)

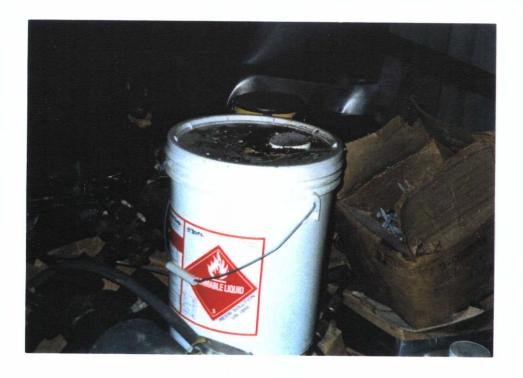
Photograph: 28 Date: October 21, 1992 Taken By: Noushin Arab

Description: Container of resin solution inside building W-47 (SWMU 36)

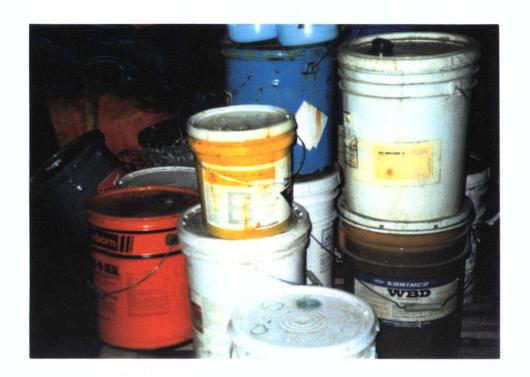
Photograph: 29 Date: October 21, 1992 Taken By: Noushin Arab

Description: Buckets which their labels could not be read in the dark (SWMU 36)

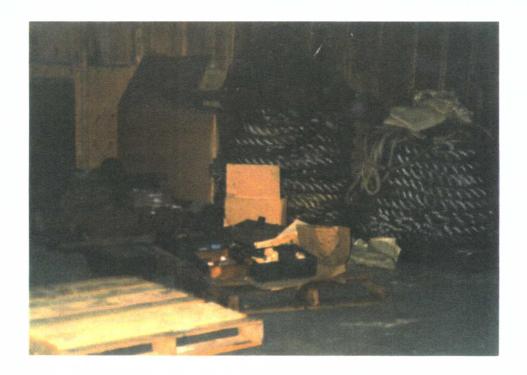
Photograph: 30 Date: October 21, 1992 Taken By: Noushin Arab

Description: Miscellaneous wastes inside building W-47 (SWMU 36)

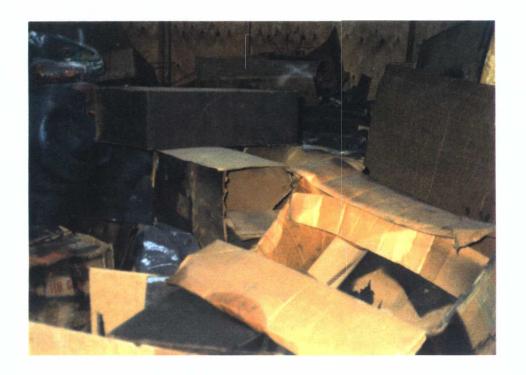
Photograph: 31 Date: October 21, 1992 Taken By: Noushin Arab

Description: Miscellaneous wastes inside building W-47 (SWMU 36)

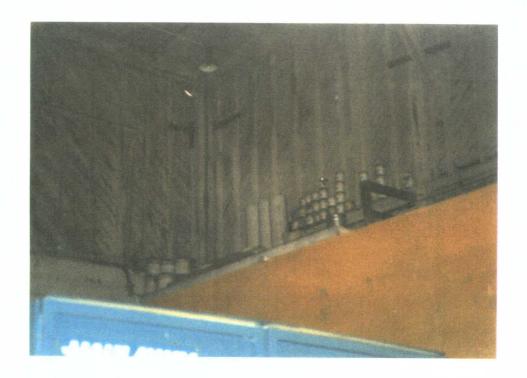
Photograph: 32 Date: October 21, 1992 Taken By: Noushin Arab

Description: Paint buckets near ceiling of building W-47 (SWMU 36)

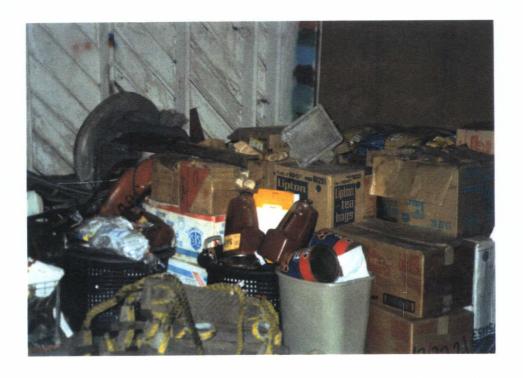
Photograph: 34 Date: October 21, 1992 Taken By: Noushin Arab

Description: Miscellaneous food items and rubbish inside building W-47 (SWMU 36)

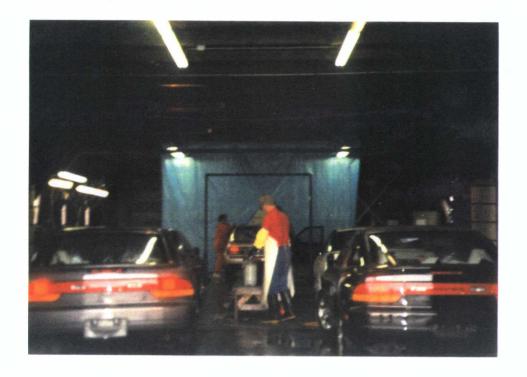
Photograph: 35 Date: October 20, 1992 Taken By: Noushin Arab

Description: Car wash station at DAS (SWMU 37)

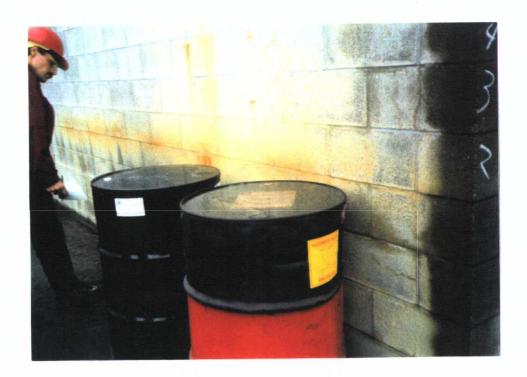
Photograph: 36 Date: October 20, 1992 Taken By: Noushin Arab

Description: Paint and motor oil waste in 55-gallon drums at DAS (SWMU 38)

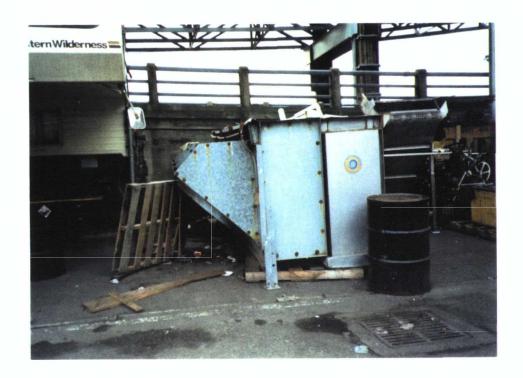
Photograph: 37 Date: October 20, 1992 Taken By: Noushin Arab

Description: An inactive heat exchanger under the freeway and a 55-gallon drum next to sewer discharge (SWMU

41)

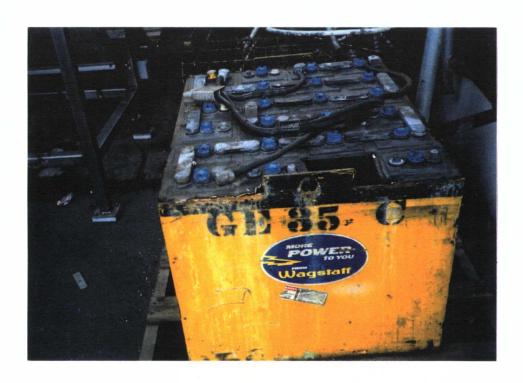
Photograph: 38 Date: October 20, 1992 Taken By: Noushin Arab

Description: Battery pack under freeway (SWMU 41)

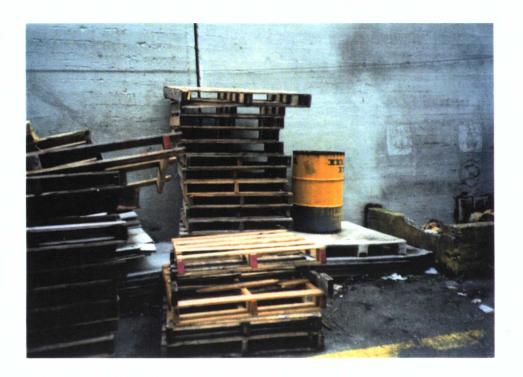
Photograph: 39 Date: October 20, 1992 Taken By: Noushin Arab

Description: 55-gallon drum with unknown content under the freeway (SWMU41)

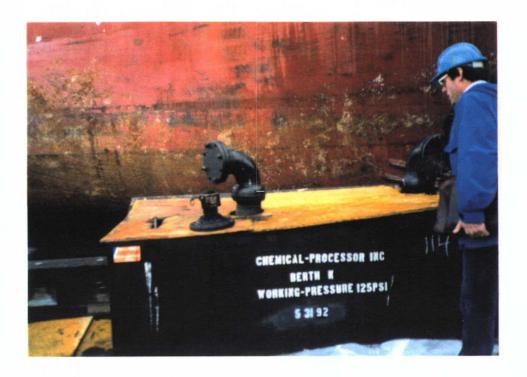
Photograph: 41 Date: October 20, 1992 Taken By: Noushin Arab

Description: Berth station located inside a steelbox on concrete surface (SWMU 43)

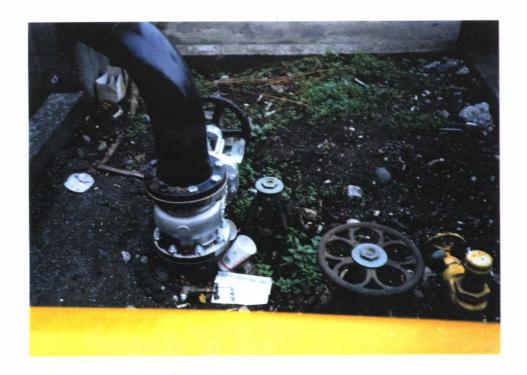
Photograph: 42 Date: October 20, 1992 Taken By: Noushin Arab

Description: Transfer piping outside Black Oil Yard (SWMU 48)

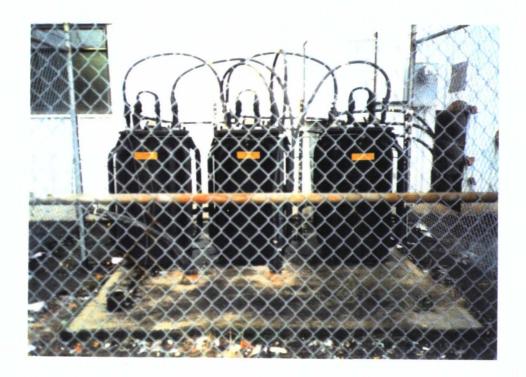
Photograph: 43

Description: Transformers next to building C-155 (AOC #16)

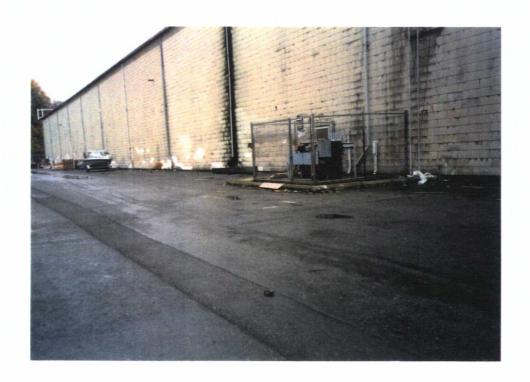
Photograph: 44

Description: Transformer next to building W-47 (AOC #16)

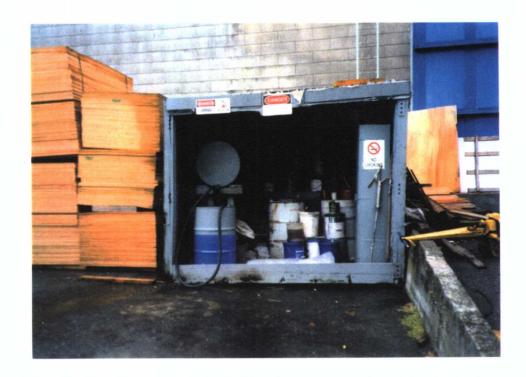
Photograph: 45 Date: October 21, 1992 Taken By: Noushin Arab

Description: Metal container outside building W-48, leased by Commercial Crating (SWMU 44)

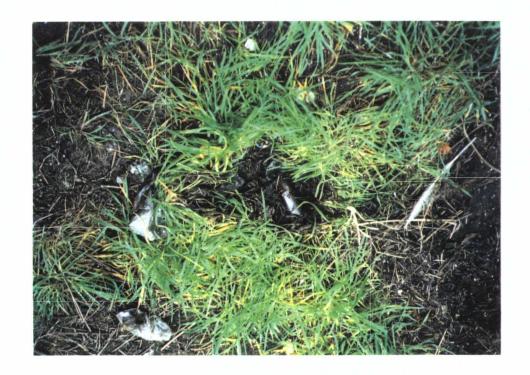
Photograph: 46 Date: October 20, 1992 Taken By: Noushin Arab

Description: Contaminated soil in the alley between Burlington and City Ice (AOC 1)

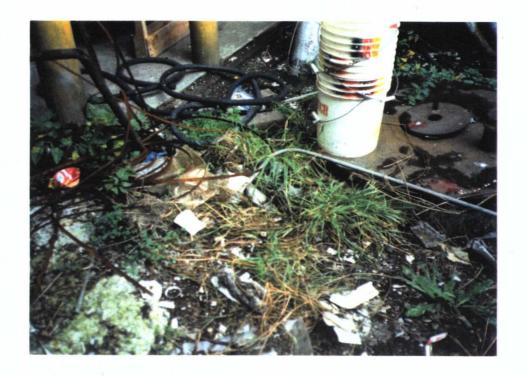
Photograph: 47 Date: October 20, 1992 Taken By: Noushin Arab

Description: Dead bird in the alley between Burlington and City Ice (AOC 1)

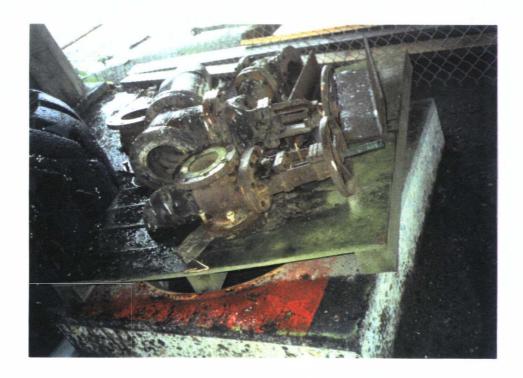
Photograph: 48 Date: October 20, 1992 Taken By: Noushin Arab

Description: Decommissioned pipeline parts on skid (AOC #3)

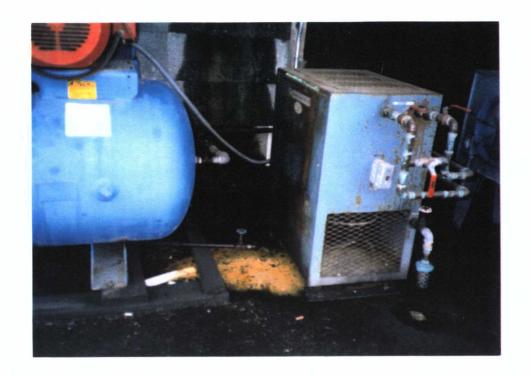
Photograph: 49 Date: October 20, 1992 Taken By: Noushin Arab

Description: Generator next to a soil stain (AOC 4)
